The Radiological Accident in Cochabamba

International Atomic Energy Agency

THE RADIOLOGICAL ACCIDENT
IN COCHABAMBA

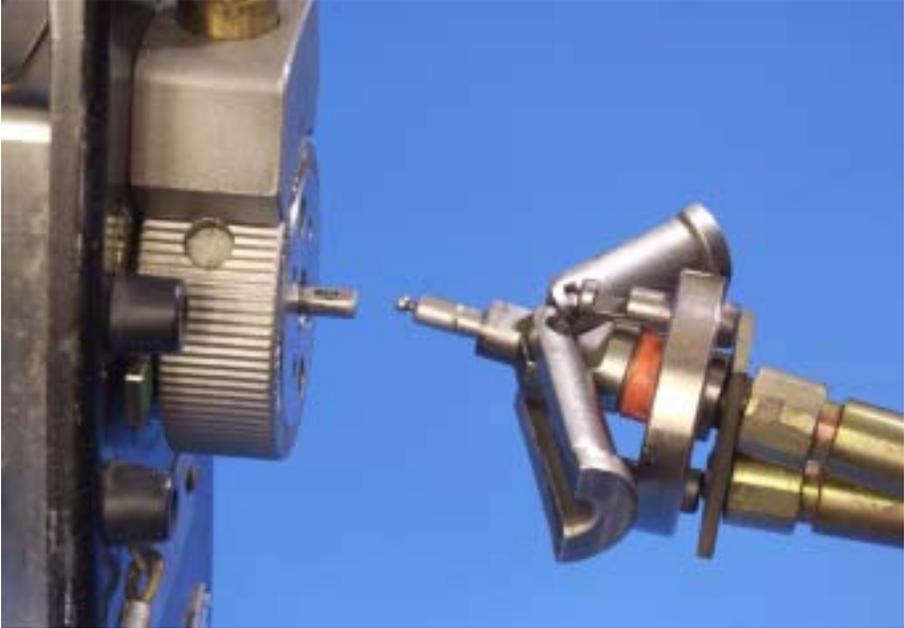
FIG. 4. Male connector on the drive cable (on the right) and female connector on the source pigtail.

- (a) Wear and tear on the components of the ball and socket joint could have allowed excessive movement of the components so that tensions caused by the frictional forces of winding the cable back through tight curves caused the ball to pop out of its socket. This could have occurred at any point during the movement of the source throughout the ten exposures.
- (b) With worn equipment it is possible to connect the drive cable tube with the ball not in the socket. The consequence is that the drive cable will push the source pigtail out at the start of an exposure but, not being connected, cannot retract it at the end of the exposure. In this accident the source would have remained in the guide tube from the first exposure, probably near the exposure end that Worker 1 would have had to handle to reposition it for each radiograph.

Wear and tear can cause components of the mechanism, particularly the ball and socket joint, to deteriorate in such a way that they no longer conform to the manufacturers' tolerances. This gives rise to the possibility of the coupling separating or of the male connector to be merely pushing against the female connector but still allowing the locking ring connection to be made. For this reason, the manufacturers of this connector specify a maintenance schedule and provide feeler gauges for testing key components.

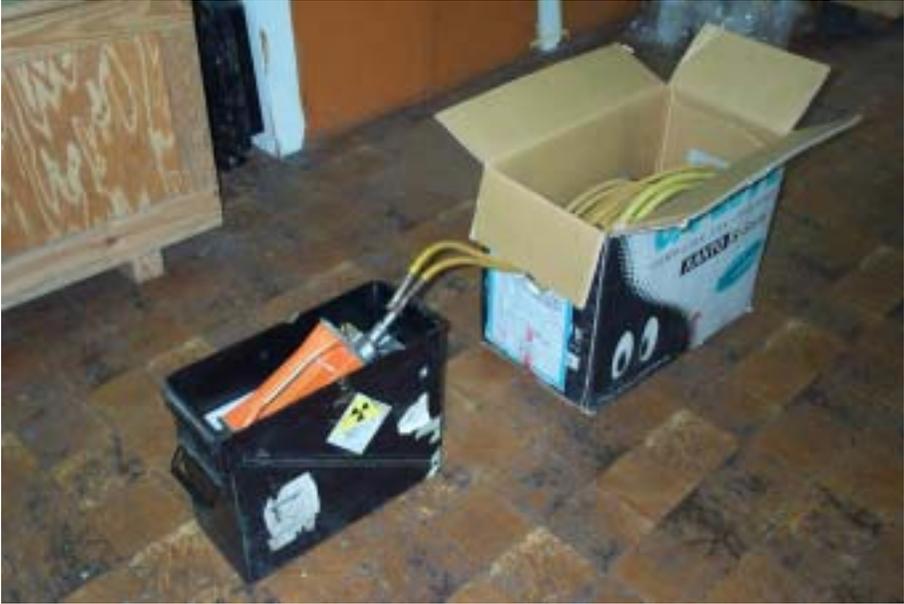
FIG. 10. Industrial radiography equipment prepared for transport in the bus.

Worker 1 did not consider these possibilities and was convinced that the source pigtail was in the container. However, crucially, he did not use his dose rate meter to check that the source was in the shielded position. He worked until 12:00 trying to solve the problem and then contacted the company's office in La Paz, explaining the situation as he saw it. It was agreed that the container and equipment should be sent back to La Paz as cargo on a scheduled long distance passenger bus. For the purpose of transporting the equipment he arranged two physically connected packages (Fig. 10).

To meet the requirements of the Transport Regulations, the source container on its own is usually placed into an overpack steel carrying case marked with transport labels for radioactive material. In this case the source container was placed at an angle in the carrying case with the attached drive cable protruding. The winding crank end was placed in a large, strong cardboard box with a hole cut in it to accommodate the drive cable (taped into position), which was still connected to the exposure container. The guide tube with the source inside it was also placed in the cardboard box.

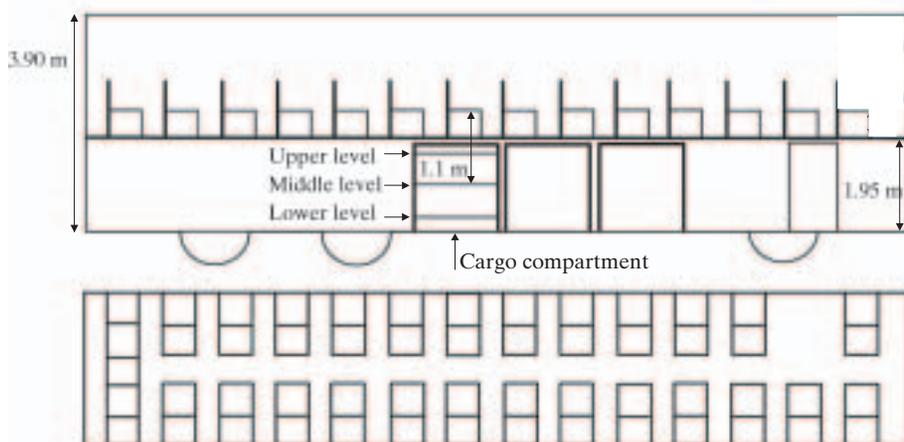
FIG. 11. Plan and elevation views of the bus in which the radiography equipment was transported.

There were three storage areas in the bus underneath the passenger deck. The forward area could be used by the off-duty driver, in cases when there are two drivers, for sleeping. For this trip to La Paz there was only one driver. The middle compartment was used for passenger baggage and the rear compartment for cargo. Where the radiography equipment and source were placed in the cargo compartment on the day of the accident is unknown. Likewise it is not known what other cargo that might have partially shielded the source was stowed in the compartment (see the assessments in Section 5.3).

The base of the cargo compartment was some 2 m below the level of the thorax of an adult in the nearest seat above.

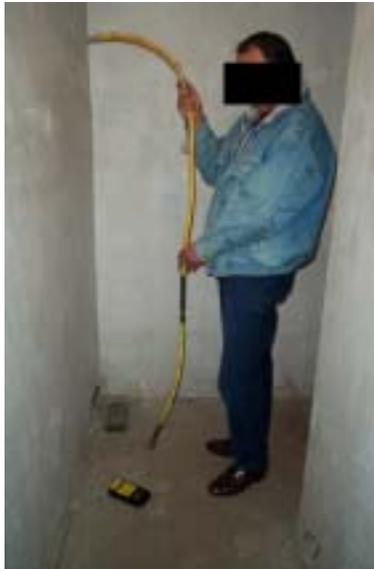
Once in the bunker, they used a dose rate meter and immediately realized that the source was exposed. The dose rates were too high for them to use the meter to determine where exactly the source was. At first it was thought that the source was in the source tube of the container but not fully shielded. Attempts were made to free the drive cable coupling but these were unsuccessful and it was eventually concluded that the source was in the guide tube. To find where the source was, the guide tube was pushed through a cable duct hole in the shielding wall of the bunker until the reading on the dose rate meter suddenly dropped. This indicated that the source was close to the snout end. The Supervisor shook the source pigtail out onto the floor without using any handling tools (Fig. 12).

FIG. 12. Re-enactment of shaking the source pigtail out of the guide tube. It should be noted that, to leave the tube, the source must necessarily have passed very close to the Supervisor's fingers.

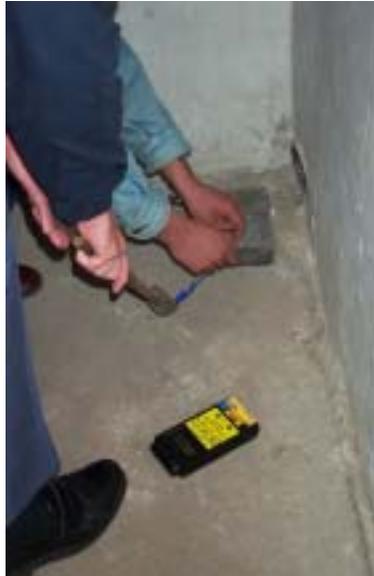
FIG. 13. Returning the source to the safe position.

pigtail, the Supervisor coupled it to the drive cable and it was rewound fully into the safe position in the source container (Fig. 13).

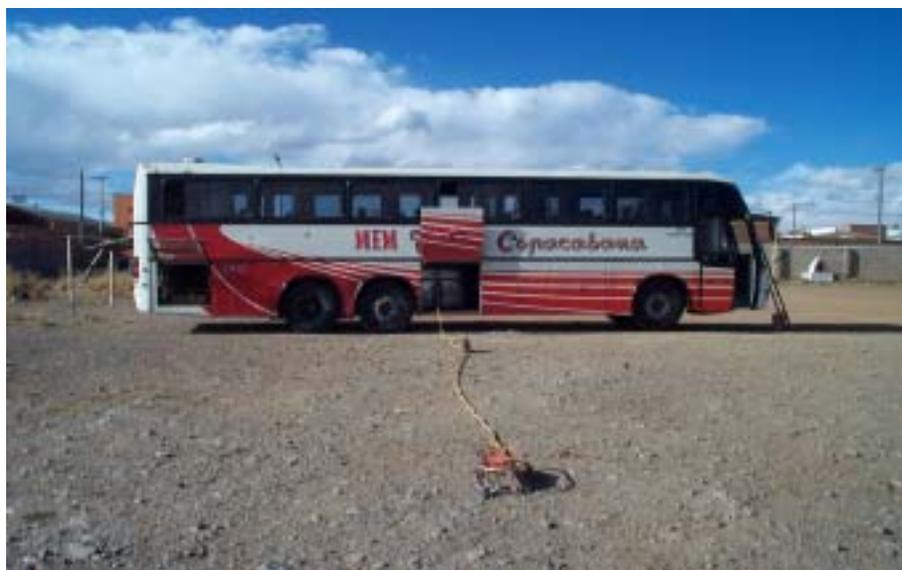
For the reconstruction, the actual equipment and the source involved in the accident were used. Decay charts indicated that the source activity was 215 GBq (5.8 Ci), less by a factor of 3.1 than at the time of the accident. The snout end of the guide tube was positioned directly under one of the seats at the middle level of the cargo storage compartment, 1.15 m below the seat (Fig. 18).

FIG. 18. Reconstruction by the IAEA of the circumstances of the accident. In the foreground is the radiography equipment with its guide tube unwound up to the cargo compartment of the bus.

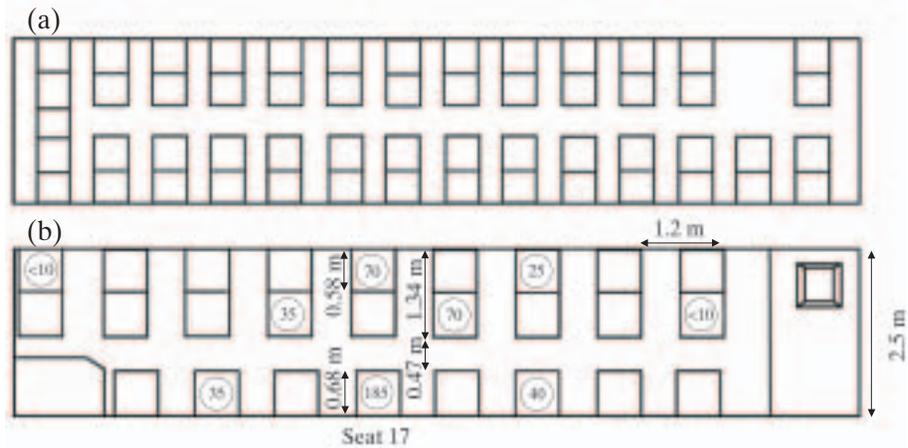
To a first approximation, the whole body dose could be taken to be the mean of the four dosimeter readings for each seat position. A more detailed assessment would not have been reasonable in view of the uncertainty in the position of the source and the unknown local shielding factors due to cargo, the passengers and their luggage. The mean and highest doses to the torso, corrected to an 8 hour exposure, are given in Table 9. The seat numbers are those on the bus used for the reconstruction.

On the basis of the uncertainties in the elevation and the lateral and longitudinal position of the source, adapting these results for the doses in the seats on the bus involved in the accident gives the broad bands of doses shown in Table 10. The values quoted have been rounded.

FIG. 20. Doses (mGy) registered by the dosimeters distributed on the bus seats during the dose reconstruction. Plan views of (a) the bus involved in the accident and (b) the bus used in the dose reconstruction.
